**San Francisco Recreation & Park Department  
Capital Improvement Program**

**Tree Assessment  
Kimbell Playground**

**June 2010**

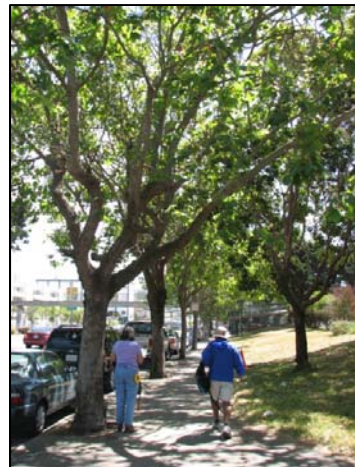
The most frequently occurring species was London plane (26 trees) (Photo 1). All London planes were street trees, located on the Geary and Steiner sides of the park. All had been installed in small (4' by 4' or less) cut-outs in the sidewalk. Trees along Geary were in better condition than those on Steiner, possible due to wind patterns. Trunk diameter ranged from 6" to 23". Most London planes were in fair condition; three (#31, 34, 36) were in good condition. Roots from trees #36 and 56 had displaced the adjacent pavement.

**Photo 1.** London planes lined Geary Street, on the north side of Kimbell Playground.

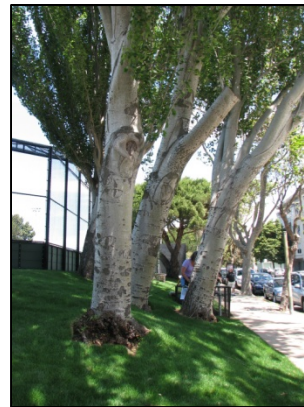
White poplar trees (16 total) were located at each corner of the park (Photo 2). Trees were mature in development with trunk diameters ranging from 11" to 25". Larger trees were in better condition than smaller. Two poplars (#68, 71) were in poor condition. Both were located on Ellis Street. Several poplars had cankers either at the base or along the trunk. These were mostly like due to infection by crown gall, a bacterial organism common to trees of this genus.

**Photo 2.** White poplars (#59 – 62) were located at the corner of Steiner and Ellis.

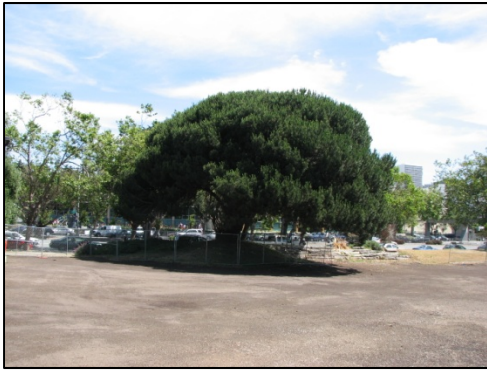
Eleven (11) Italian stone pines were concentrated in the park area north of the playfields (Photo 3, following page). All stone pines were mature in development with trunk diameters between 28" and 52". Condition was fair for all except tree #27 which was poor. Stone pines had high crowns, with either codominant or multiple trunks that arose below 12'. Several trees were leaning and/or bowed. Stone pines #27 and 73 had major stems removed, most likely due to their failure.

**Photo 3.** Italian stone pine #27 was in poor condition.

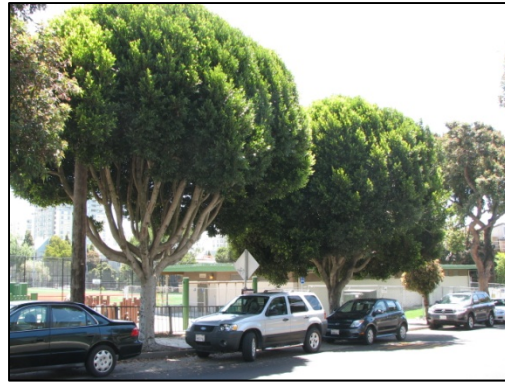
**Photo 4.** Two of the fig trees located on Pierce Street.

- 3 figs were located on Pierce Street (Photo 4 above). All were in fair condition with multiple attachments at 6'.
- 3 blackwood acacias were located on Ellis Street. All were mature in development. Tree #63 was in poor condition; #66 and 78 were fair.
